# Campus and Facility Assessment Report

Holy Cross Episcopal Church  
11526 162<sup>ND</sup> Avenue NE  
Redmond, WA 98052  
June 1, 2006

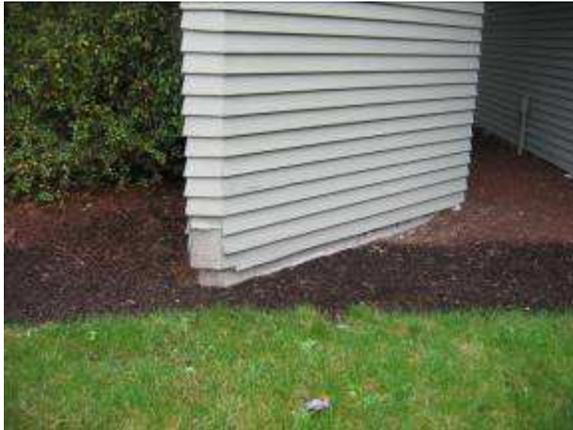
- Exterior siding appears to be well maintained although several soft spots suggest there was a gap in maintenance. Recommend close evaluation / replacement of exterior siding with any major remodeling project. (*see picture*)

- Could have a qualified testing agency perform a more detailed inspection of the siding.
- In some areas, the landscape bark or sidewalk is less than 6 inches below siding, causing premature deterioration of siding.

Deteriorating Exterior Siding

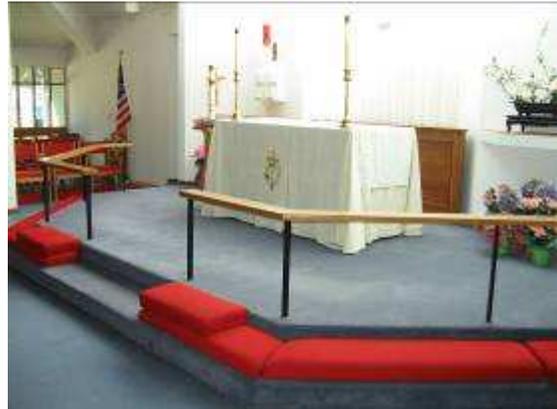
- Bathroom accessibility does not meet current standards; toilet stalls are too small.
- The Altar/Platform has two steps and no ramp *(see picture)*
- The Sacristy is two steps above the Sanctuary floor and has a narrow Hall. *(see picture)*

Two Steps to Altar (No Ramp)

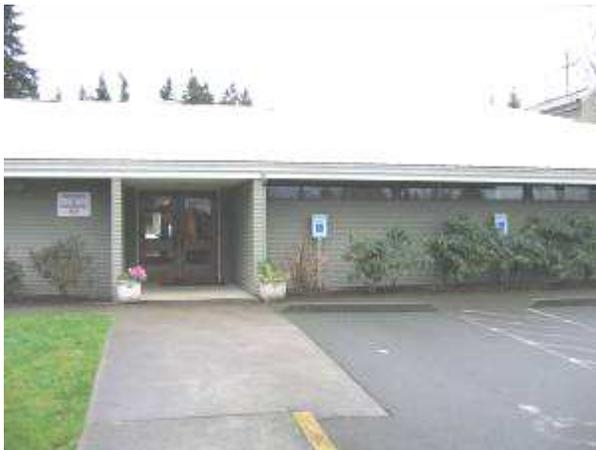
- Insufficient amount of wood shear walls for current code requirements especially in the east-west direction. *(see picture)*
- It was observed that the roof blocking to the exterior walls did not extend to the roof sheathing. This results in an incomplete lateral load path from the roof to the shear walls.
- The 4x4 porch posts along the east elevation have no post-to-beam connectors. This is a very marginal connection and could fail in an earthquake, resulting in possible collapse of the roof overhang above the exitways. Additionally, the 4x10 beams' existing splice cut connection have resulted in splits in two of the beams, further degrading the connection and load carrying capacity. *(see picture)*

Lack of Seismic Connections

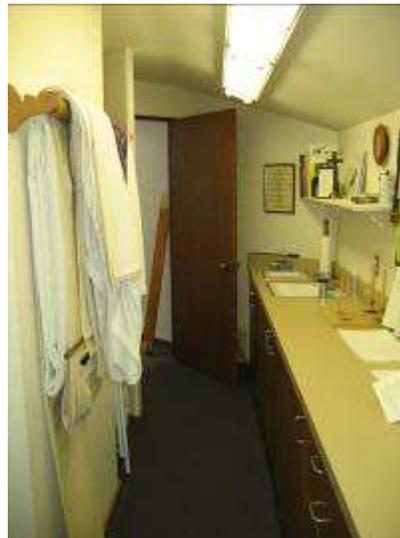
Cramped Sacristy (Not Barrier-free)

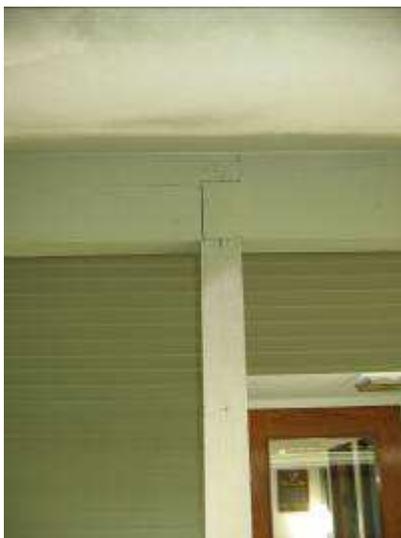
Weak Beam/Post Connection

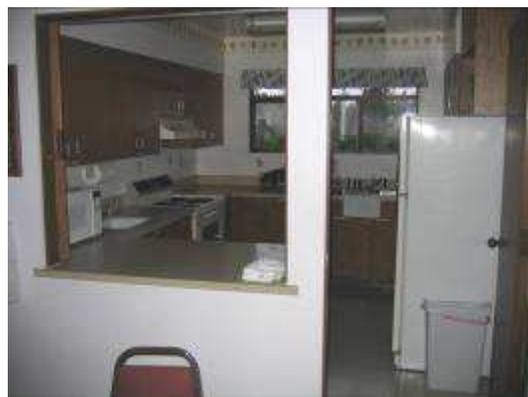
Cramped Kitchen

- Kitchen (Food Preparation): the existing food preparation area is too small. A master plan should evaluate the food preparation needs and program a much larger Food Preparation Area (4x to 6x existing area) (*see picture*)

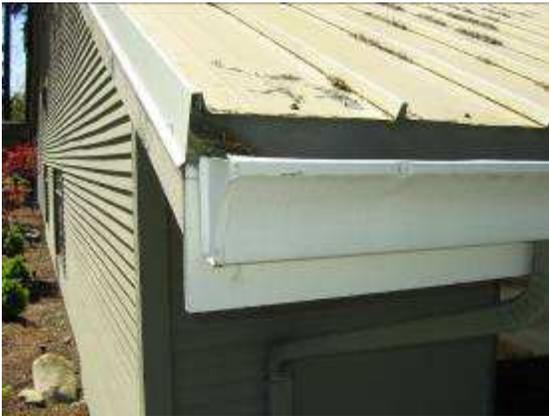
- Phase 1 roof originally shingles (per drawings). Replaced with metal roofing when Phase 2 built.
- Metal roof painted by Owner in 2004. Some of the paint is bubbling and cracking off. (*see picture*)
- Could have a qualified testing agency perform a more detailed inspection of the roofing.
- Roof maintenance is only fair. This roof is under a grove of trees and much more tree debris is laying on the roof, suggesting it will have a shorter life span than the Sanctuary roof. The ridge vent is also clogged reducing ventilation of the attic. (*see pictures*)

Cracked Paint at Metal Roof

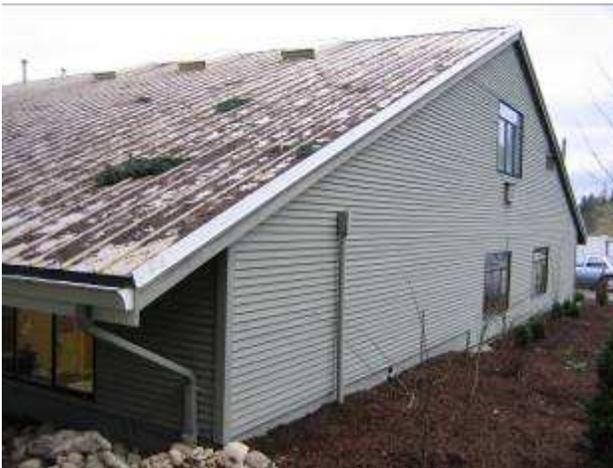
- Walls: generally good. Siding is much newer than Building 1: Sanctuary, so generally better condition but more instances of siding less than 6 inches to dirt which can lead to premature rotting. Also the east façade has no roof overhang so the siding is much more subject to the weather. (*see picture*)
- In some areas, the landscape bark or sidewalk is less than 6 inches below siding, causing premature deterioration of siding.
- Windows: some windows have lost their seal, thus fogged and lost insulation value.

Tree Debris on Roof  
Lack of Roof Overhang on East Side

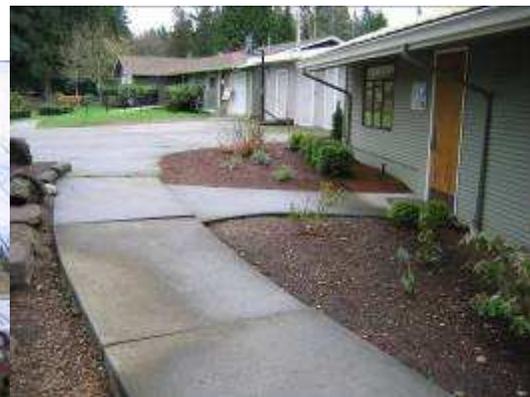
- The walkway to the northeast entry door is not barrier-free. The walkway needs to have a full 18 inches beyond the latch side of the door and be relatively flat. Also, the walkway has settled creating a significant trip hazard.
- Restrooms are spacious and appear to be in current compliance with Barrier-free codes
- The only access to the upper level class and office is via one stairway, thus access is not barrier-free. The current building code allows the upper level to be up to 3,000 SF without being barrier-free. The existing upper level is 637 SF.

Dangerous Walk

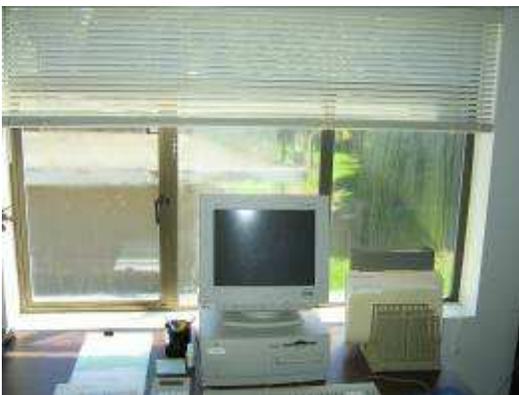
- Windows: some windows have lost their seal, thus fogged and lost insulation value. (see picture)

Loss of Window Seal

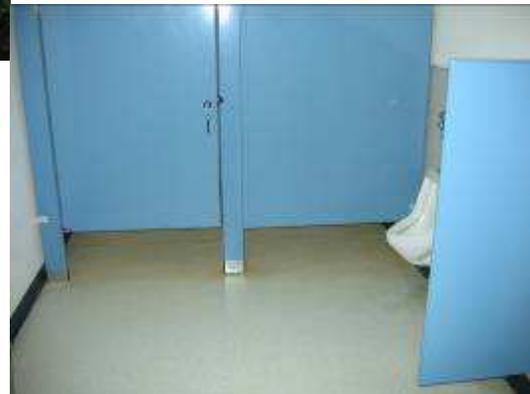
Barrier-free Restroom

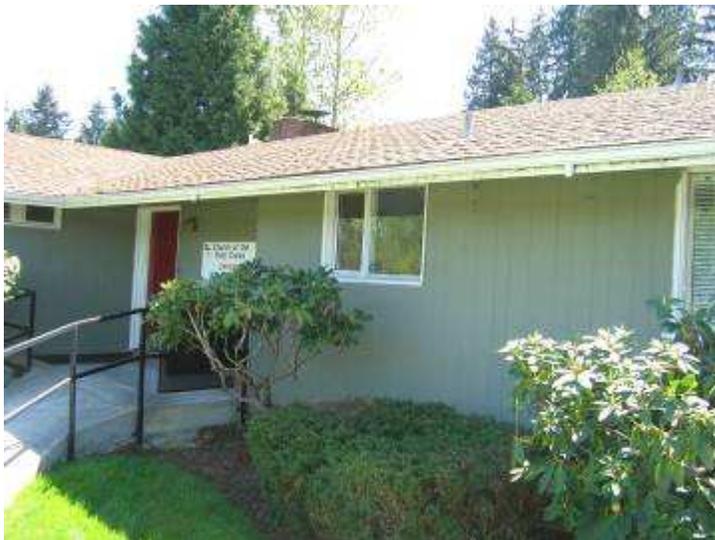
Lack of Downspouts

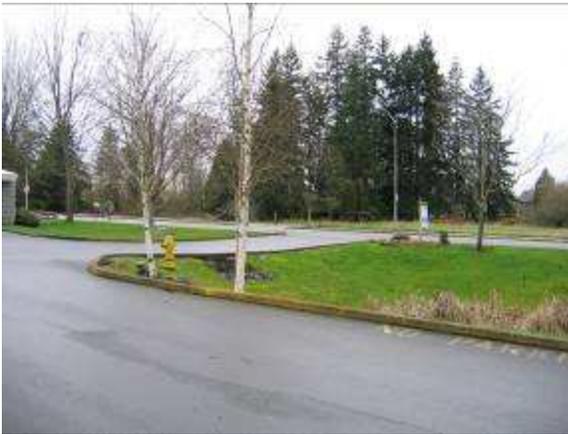
- Exterior sidewalks: some cracking and signs of chemical degradation south of Sanctuary Building.
- The parking lot striping and symbols need to be re-painted
- Paving has collapsed near trees north of Sanctuary Building and around underground drainage structures. (*see picture*)

Settling Pavement near Trees

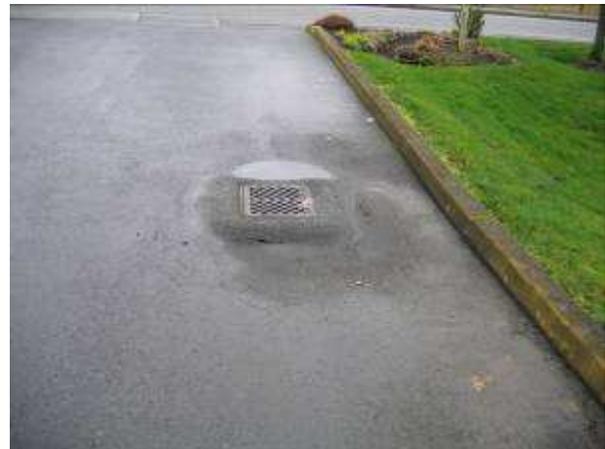
Settling Pavement around Drainage Structure
