# Campus and Facility Assessment Report

Holy Cross Episcopal Church  
11526 162<sup>ND</sup> Avenue NE  
Redmond, WA 98052  
June 1, 2006

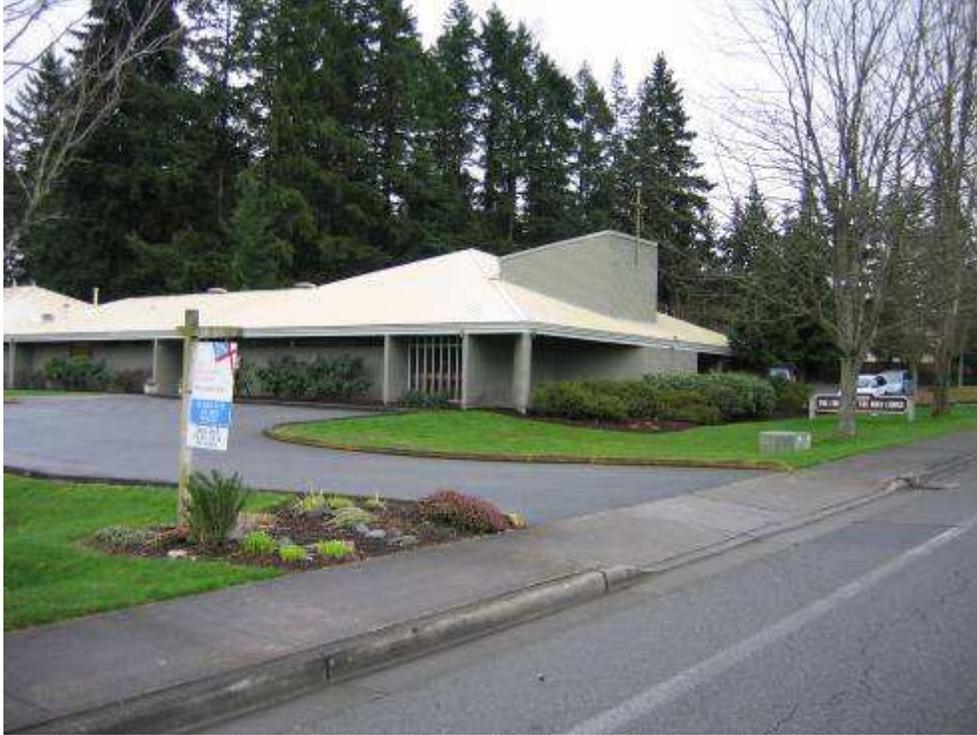
## **Building 1: Sanctuary**

- Well maintained

- Roof –originally shingles which were replaced with metal roof.
- Metal roof painted by Owner in 2004; some of the paint is bubbling and cracking off.
- Flashing was added to alleviate leaking at the skylight
- Could have a qualified testing agency perform a more detailed inspection of the roofing.

- Exterior siding appears to be well maintained although several soft spots suggest there was a gap in maintenance. Recommend close evaluation / replacement of exterior siding with any major remodeling project. (*see picture*)

- Could have a qualified testing agency perform a more detailed inspection of the siding.
- In some areas, the landscape bark or sidewalk is less than 6 inches below siding, causing premature deterioration of siding.

- Insufficient amount of wood shear walls for current code requirements especially in the east-west direction. *(see picture)*
- It was observed that the roof blocking to the exterior walls did not extend to the roof sheathing. This results in an incomplete lateral load path from the roof to the shear walls.
- The 4x4 porch posts along the east elevation have no post-to-beam connectors. This is a very marginal connection and could fail in an earthquake, resulting in possible collapse of the roof overhang above the exitways. Additionally, the 4x10 beams' existing splice cut connection have resulted in splits in two of the beams, further degrading the connection and load carrying capacity. *(see picture)*

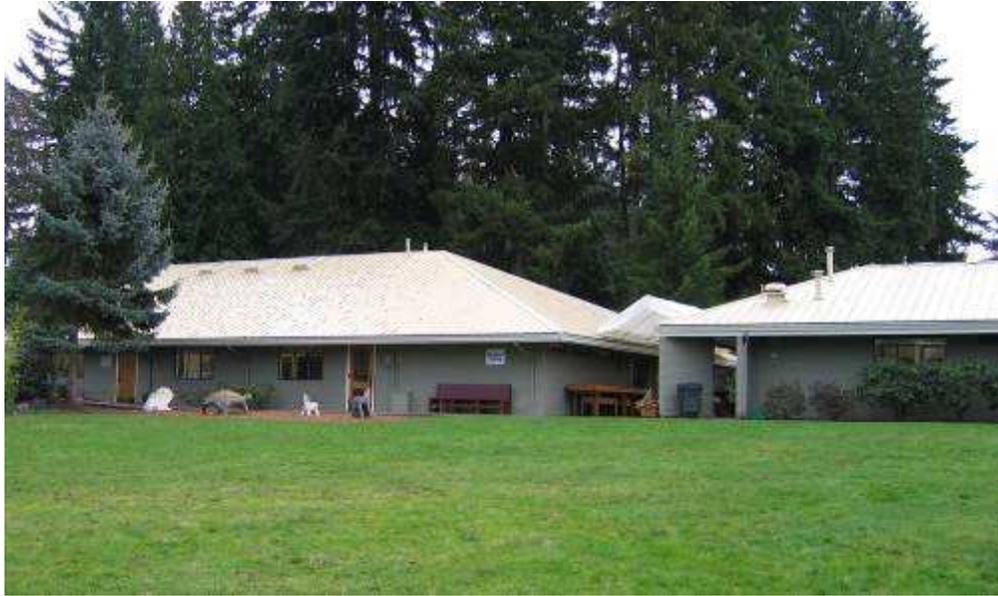
**Building 2: Education**

- Phase 1 roof originally shingles (per drawings). Replaced with metal roofing when Phase 2 built.
- Metal roof painted by Owner in 2004. Some of the paint is bubbling and cracking off. (*see picture*)
- Could have a qualified testing agency perform a more detailed inspection of the roofing.
- Roof maintenance is only fair. This roof is under a grove of trees and much more tree debris is laying on the roof, suggesting it will have a shorter life span than the Sanctuary roof. The ridge vent is also clogged reducing ventilation of the attic. (*see pictures*)

- Walls: generally good. Siding is much newer than Building 1: Sanctuary, so generally better condition but more instances of siding less than 6 inches to dirt which can lead to premature rotting. Also the east façade has no roof overhang so the siding is much more subject to the weather. (*see picture*)
- In some areas, the landscape bark or sidewalk is less than 6 inches below siding, causing premature deterioration of siding.
- Windows: some windows have lost their seal, thus fogged and lost insulation value.

- The interior, in general, is well maintained.
- Some of the sheet vinyl floors in the restrooms have developed significant gaps at the seams and may need replacement in the near future.

- The walkway to the northeast entry door is not barrier-free. The walkway needs to have a full 18 inches beyond the latch side of the door and be relatively flat. Also, the walkway has settled creating a significant trip hazard.
- Restrooms are spacious and appear to be in current compliance with Barrier-free codes
- The only access to the upper level class and office is via one stairway, thus access is not barrier-free. The current building code allows the upper level to be up to 3,000 SF without being barrier-free. The existing upper level is 637 SF.

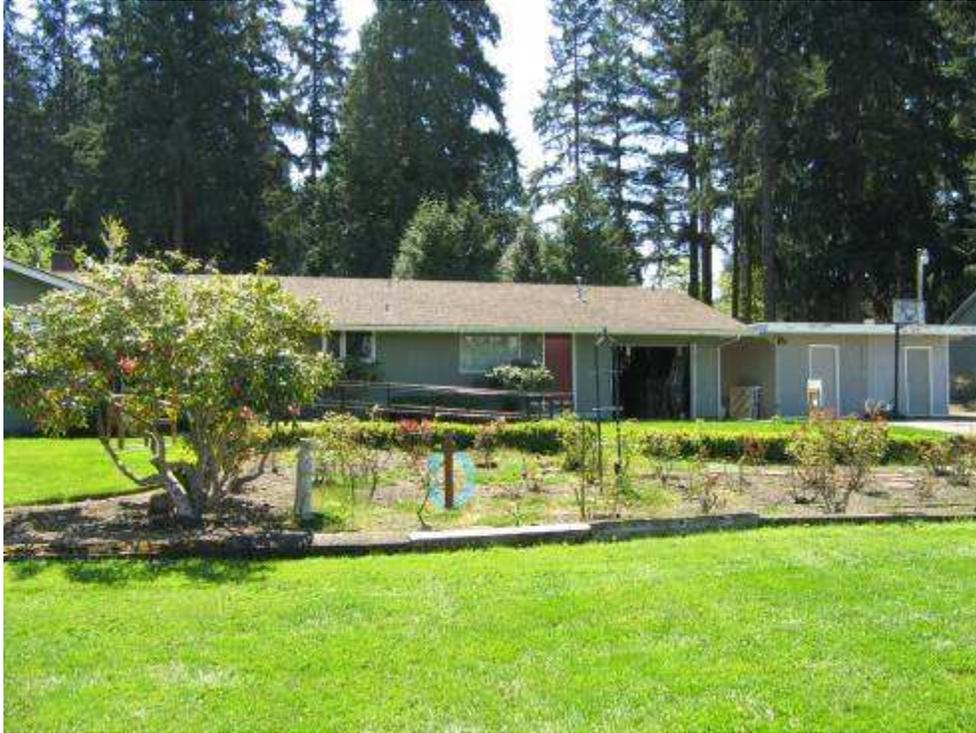
### **Building 3: Administration**

- Appears maintenance has been only fair on this house.
- The roofing material is an unusual textured product, apparently no longer available on the market. The disadvantage of the texture is that it accumulates tree debris thus accelerating its own deterioration.
- The house has a musty smell indicating that moisture has been in the crawl space. Two downspouts were missing in the front which could be one contribution to moisture in the crawl space. It was reported there is no drainage, no floor insulation and no vapor barrier on the ground in the crawl space. 3442

- This structure was originally a single-family residence. The codes for single-family residences are very different from codes for commercial buildings.
- The restrooms do not meet the current barrier-free accessibility codes.
- Based on the building’s age, structurally, the building likely lacks bolts to the foundation.

- The current configuration is very inadequate for office use. The current use is one of toleration and accommodation.
- It is quite likely that some of the materials in the construction contain asbestos and lead and would require abatement for a remodel.
